CASE STUDY: Two units at the Cortland Whitehall Apartments were showing signs of settlement-related distress. UMA chose the UDI Deep Injections method to improve the soils below the slab and correct the settlement problem.

HIGH-DENSITY POLYURETHANE RESIN (HDPR) INJECTION

THE PROJECT

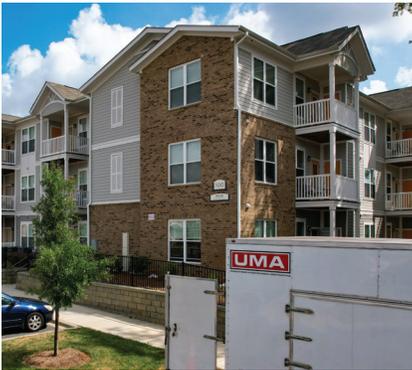
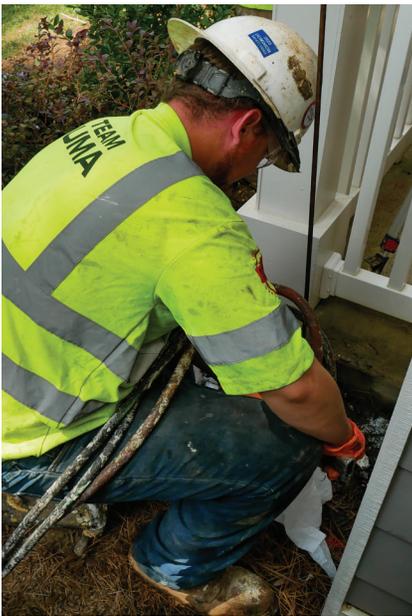
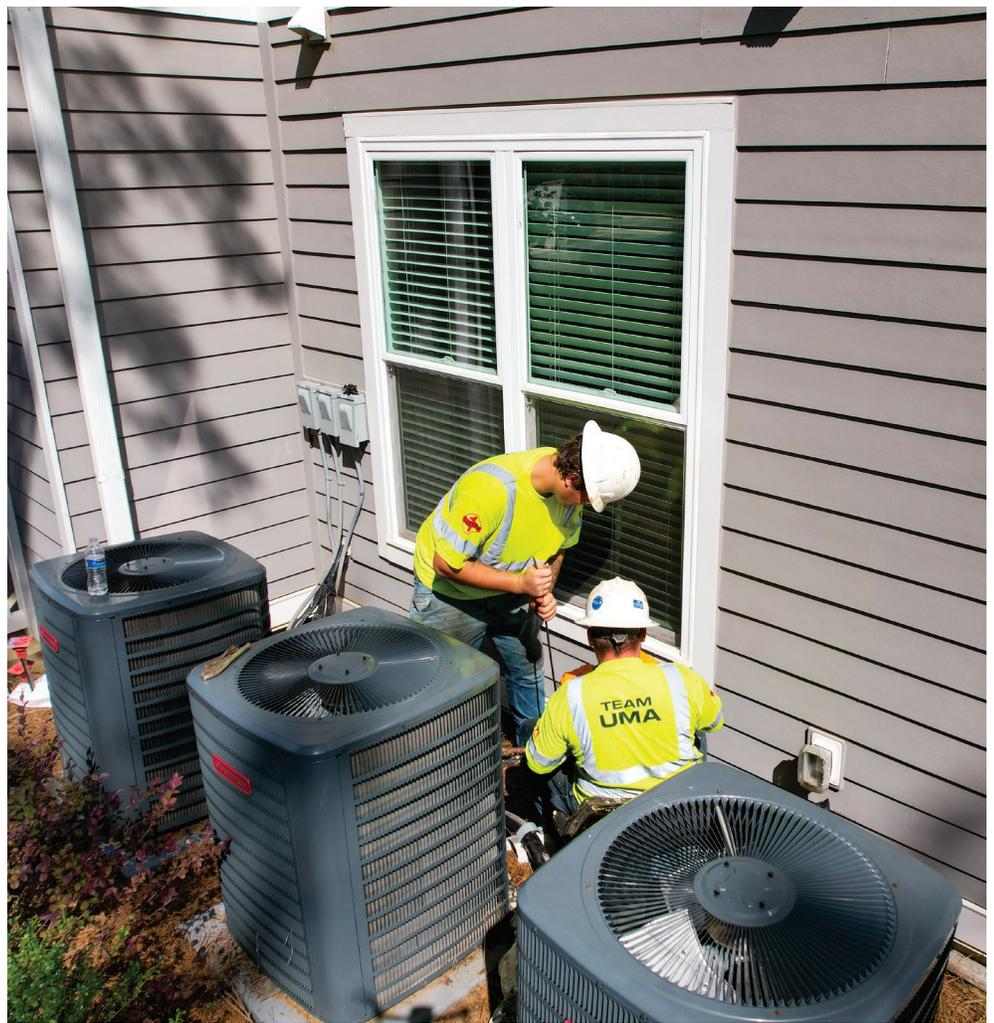
UMA Deep Injections (UDI) were selected as the best strategy to lift the structure and close wall separations. We inserted steel tubing 3 and 6 feet below the slab and along the exterior foundation. Our subcontractor GPRS, Inc. located post-tensioned strands on 3-foot centers, so we successfully adjusted the typical injection pattern to avoid the stands located in the slab.

Our UDI Injections proved to be the right method to correct settlement issues at Cortland Whitehall. The damaged post-tensioned strand issue was also an example of UMA's ability to adjust to and correct unexpected issues that arise. We worked inside and outside of the building without causing disruption. More importantly, our ability to fill voids and close many of the surface cracks previously noticed along the structure restored safe living conditions for the residents.
